Manhole Inspection Summary

Manhole # S35G__071MH

Insp Date: 1/15/09 9:12 AM

Location Address: **37 s charles st**

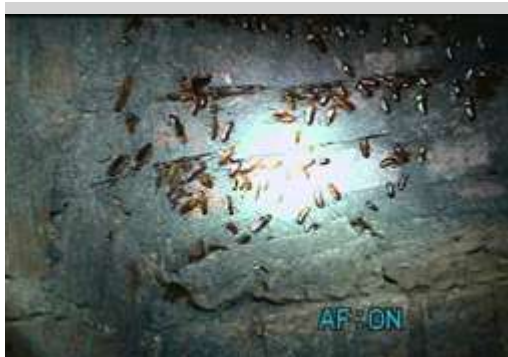
MISC

bench debris

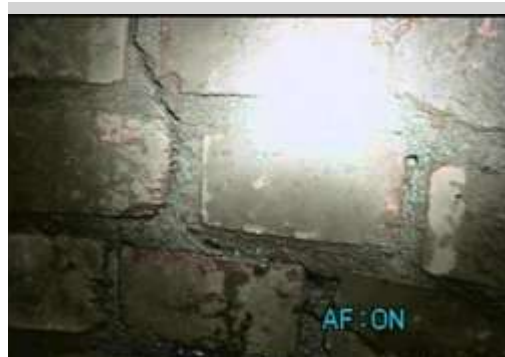
Defect 5

☒ **Cracked**

☒ **Mortar**

corbal cracked, infiltration mortar

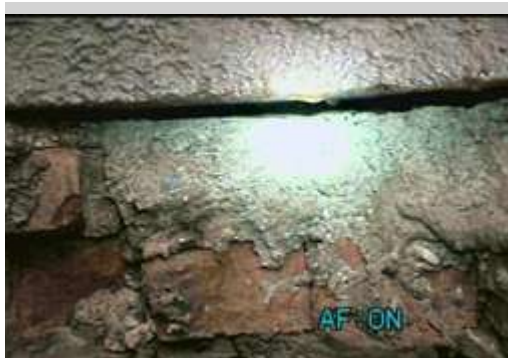
Defect 4

☒ **Leaks**

☒ **Loose Brick**

☒ **Deteriorated**

frame leaks, chimney loose bricks, deteriorated

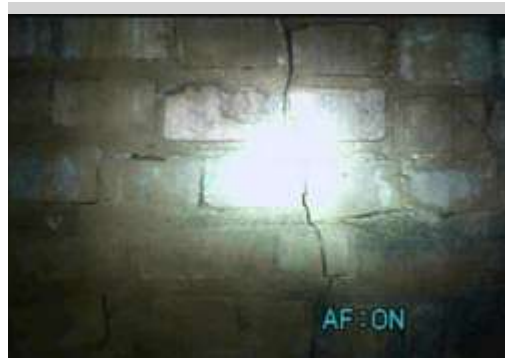
Defect 2

☒ **Cracked**

cracked barrel

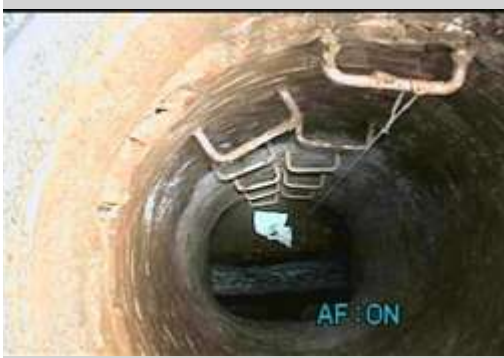
Defect 1

☒ **Corroded**

corr steps

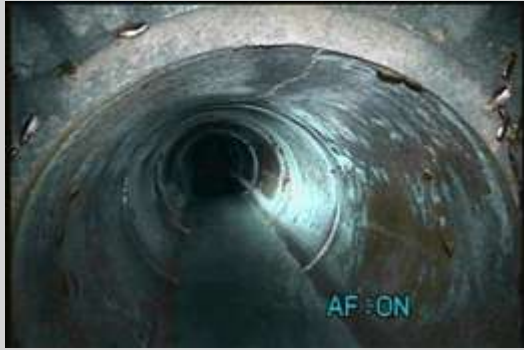
6 O'Clock Inflow

cracked top
